DEPARTMENT OF NATURAL RESOURCES
DIVISION OF OIL, GAS AND MINING

RE: Site Inspection, Tom Lammert, Monti Cristo Mine, S/037/118, San Juan County, Utah

Date of Inspection: October 8, 2003
Time of Inspection: about 8:15 to 8:35 a.m.
Conditions: Clear, 60's
Participants: Denice Swanke, Moab BLM; Paul Baker, DOGM

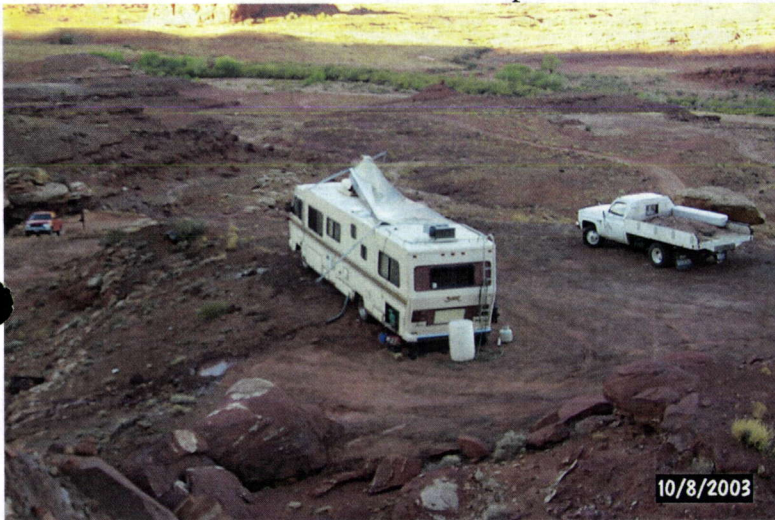
I took a GPS reading at a gate, and the road continues up to a pad where the operator has a motor home and a truck (Photo 1). Our red pickup is visible on the left side of this photo, and it was parked just outside the gate. A flexible pipe extended from the motor home to a small depression, and it appeared gray water was being allowed to drain directly from the motor home into this depression.

Photo 1. Part of the lower pad. Note the drain pipe coming from the left side of the motor home and leading into a small depression.

The BLM has been working with the operator on the issue of dumping water from the motor home to the small depression on the ground surface. I'm sure the County has requirements for disposal of this water, but unless the BLM is not able to get this situation resolved, I will not contact the County.

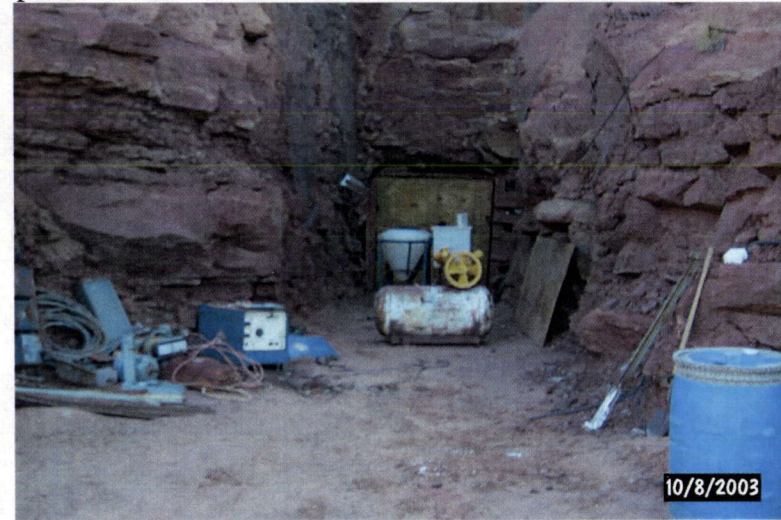
(Photo 3) was blocked with plywood, and Ms. Swanke believes the operator is using this portal for equipment storage.

Photo 3. The portal the operator appears to be using.

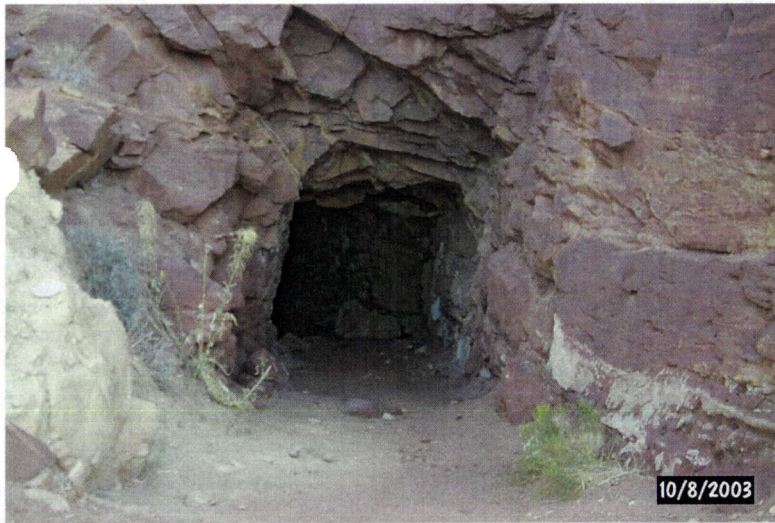
From this lower pad, there is a road leading to an upper pad and two portals. One of the portals, shown in Photo 2, does not appear to have been used recently. The other portal

Photo 2. An open portal at a lower elevation than the one shown in Photo 3.

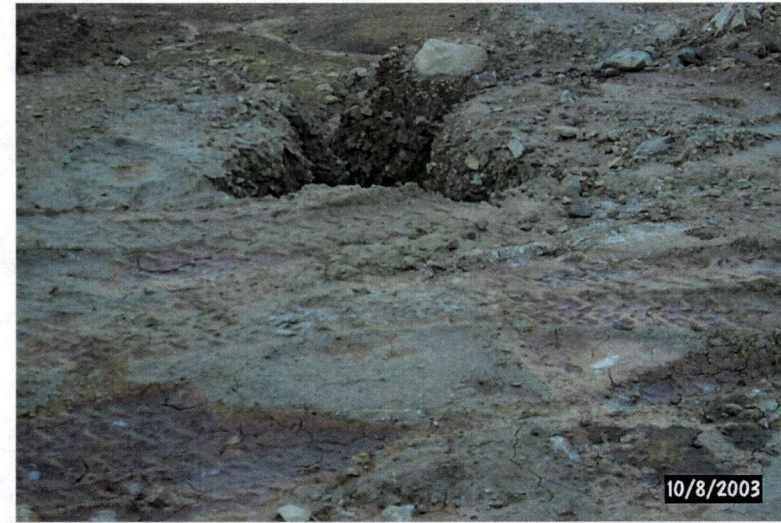
The lower left portion of Photo 4 shows an area where there was an oil spill. The operator was supposed to have dug up this material and placed it where it could be aerated, but this had not happened. This photo also shows where runoff appears to have gone over the edge of the pad creating a gully.

Photo 4. An oil spill is shown in the lower left of this photo, and the upper center shows the top of an erosional gully.

As required by the BLM, the operator needs to pick up the soil on which oil was spilled and to aerate it. In addition, a berm should be built around the edge of the pads to keep water from eroding the pad outsoles.

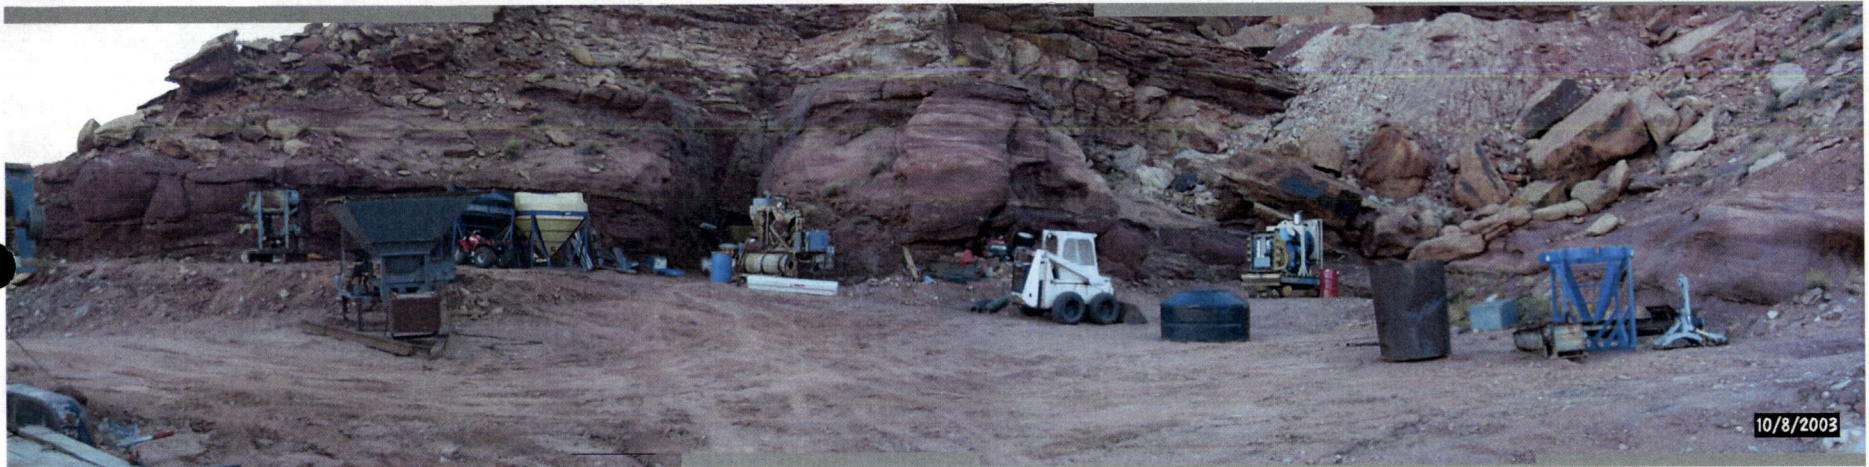
There were several pieces of equipment on the upper pad, and they are shown in Photo 5. This photo is a composite of four pictures.

Photo 5. A panorama view of the upper pad and the equipment.
